Manhole Inspection Summary

Manhole # S35YY_021MH

Insp Date: **12/22/06 1:59 PM**

Location Address: **3200 GUILFORD AVE**

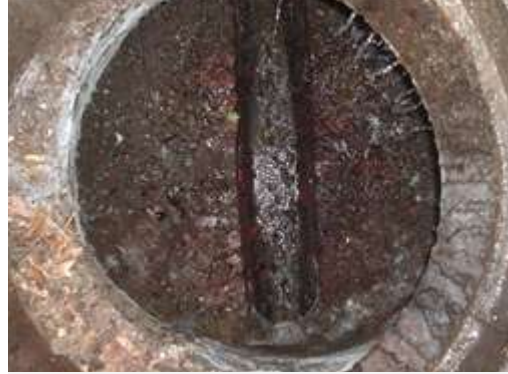
Top View

Bench and Channel debris.

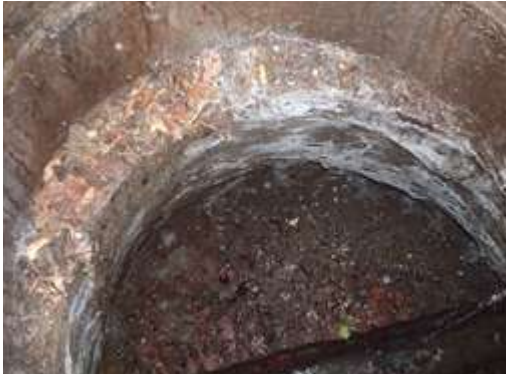
Defect

☒ **Leaks**

Condition: ☐ Sound ☐ Cracked ☐ Root Intrusion ☐ Loose Brick ☒ **Deteriorated**

Infiltration: ☐ None ☒ **Joint** ☐ Cracks ☐ Mortar ☐ Roots ☒ **Wall**

Infiltration: ☐ None ☐ Joint ☐ Cracks ☐ Mortar ☐ Roots ☒ **Wall**

Frame leaks. Frame offset. Adjustment deterioration and infiltration. Barrel infiltration.

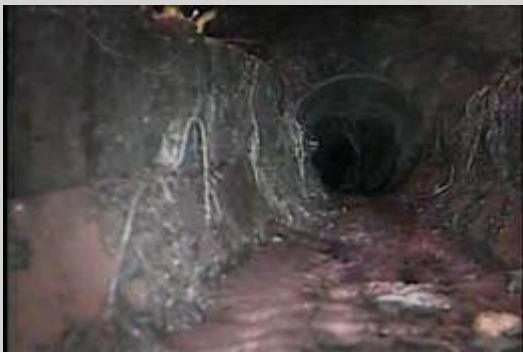
8 in. Circular Gravity Sewer Pipe Out @ 12 O'Clock

Channel root intrusion.

Infiltration: **None** Pipe Seal Cond: **Roots**

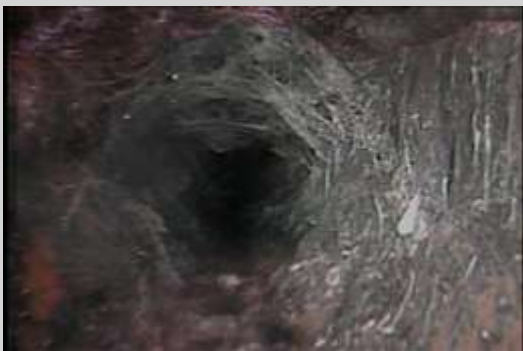
8 in. Circular Gravity Sewer Pipe In @ 6 O'Clock

Deposits: ☐ None ☐ Mud ☐ Sludge ☒ **Debris** ☐ Grease

Silt Depth: **0** (in.) Deposits Extent: **Light**

Infiltration: **None** Pipe Seal Cond: **Roots**
